Diversions Diagnosis

by Matthew McDaniel

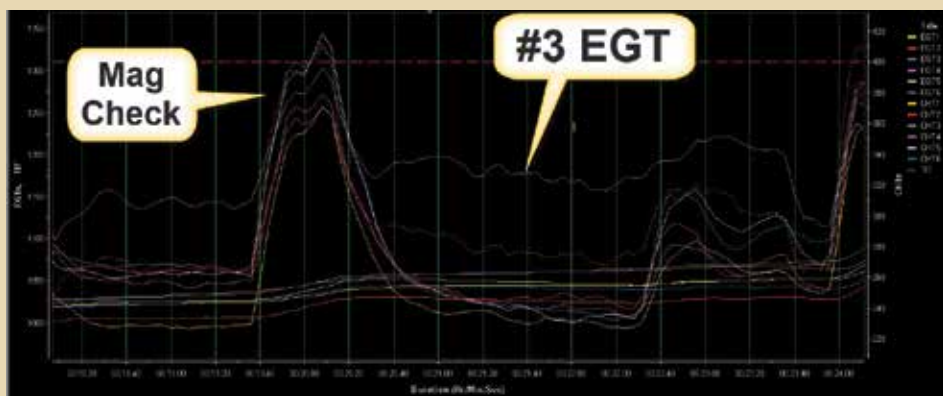
With the engine warm and run-up complete, four minutes passed as I finished checklists, double checked my inputs into the FMS and my iPad's[®] ForeFlight[®] app, and awaited the tower's departure clearance. Had I been staring at the R9's Engine Monitoring page during that time, rather than dancing between the other important tasks, I might have seen it then, but I wasn't ... and I didn't [Figure 1].

Figure 1: Post-flight analysis of the pre-flight engine run-up. All is normal during startup and taxi. At the 10-minute mark (far left end of graph), the #3 EGT rises about 100 degrees above the rest, but stays relatively cool at only 1,150 degrees. The mag-check is the spike around the 20 minute mark. After which, the #3 EGT (grey) stays warmer than the others. Yet, when the power comes up again (at 00:22:40) to taxi into position on the runway and again at takeoff (00:24:00), the other EGTs close the gap between themselves and #3. It's easy to see and diagnose this via digital engine data, after the fact, but, at the time, not so much. The temperature variation is only about 100 degrees over a four-minute span, and all of it below 1,200 degrees (a temp low enough to not be cause for concern, all by itself). Add to this, a busy time of completing checklists, FMS programming, and ATC communications. The takeoff occurs just before 24 minutes, during which, the #3 EGT is again "running with the pack" and of no cause for concern. The signs were there, but would you have seen them? The #3 cylinder is one of three later determined to have over-tight valve guides, which was the likely cause of the temperature anomalies seen here.

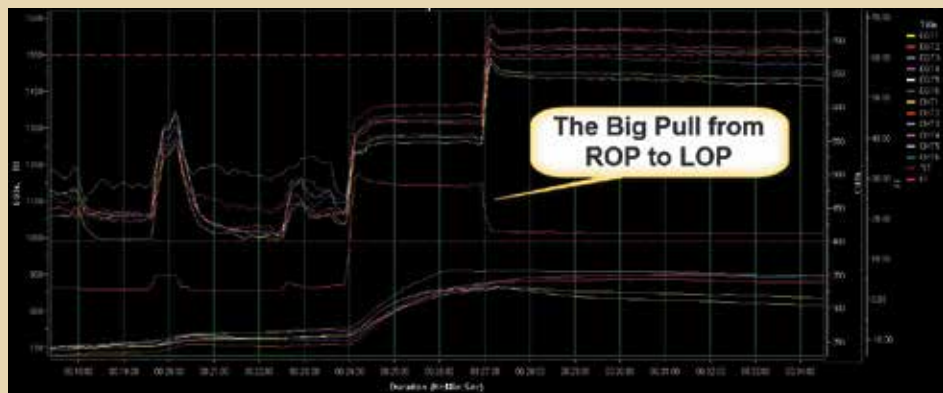
While it is certainly not Wisconsin, it was still a brisk morning and the plane climbed with gusto at over 1,000 feet per minute. On course to the initial waypoint, I was climbing at 140 KIAS. I had a long flight ahead and hoped with good fuel management to complete it non-stop. At 3,000 feet AGL, I leaned the mixture briskly for a fuel-conserving, Lean-of-Peak climb [Figure 2].

Figure 2: Three minutes after takeoff (at 00:27:00), "The Big Mixture Pull" is performed to achieve the most efficient climb fuel flow to conserve fuel for the long flight ahead. Thereafter, the engine was running well with less than a 50-degree spread across the CHTs and about a 100-degree spread across the EGTs. Fuel flow is stable at 17.5 GPH and the TIT is happy at a relatively cool 1,560 degrees.

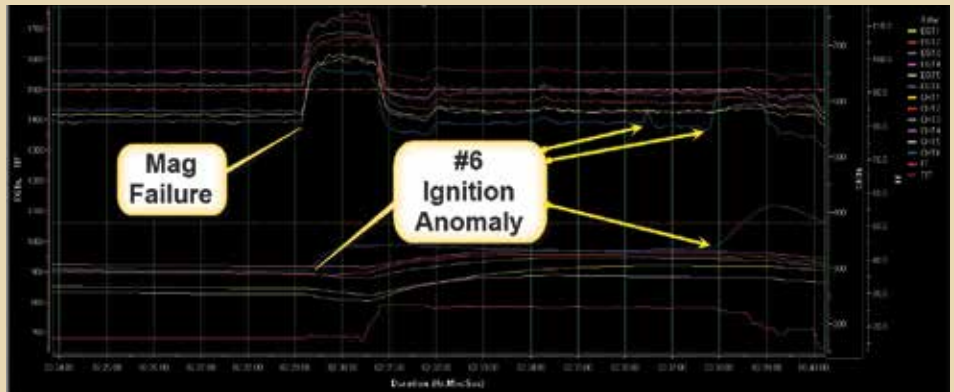
Figure 4: Two hours and 29 minutes into the flight, a magneto failure occurred, causing the initial engine shudder. Within two minutes, engine parameters had re-stabilized and the mixture to a Rich-of-Peak fuel flow was reset, but the effects of running on a single mag are obvious in this engine data. The "failed" mag (which had sheered about 25% of its drive-gear teeth [Photo 1] likely continued to function in a reduced and intermittent capacity, functioning intermittently from close to normal, to not at all, or somewhere in between. This mag malfunction, combined with a malfunctioning #6 spark plug, and at least three cylinders that were found to have overly tight valve guides, likely all contributed to the engine temperature anomalies during the flight. The first ignition anomaly occurred with the mag failure at 2:29, but the worst one (suspected detonation) is at 2:38. This was the point where the engine began to shudder wildly as the #6 EGT and CHT shot towards their limits. None of the subsequent ignition or temperature anomalies were nearly this severe, as they occurred while operating at greatly reduced power settings.

full-screen engine monitor. I stared at it for perhaps a minute, while making slight adjustments to the power and mixture. The EGTs had all spiked slightly and briefly, but within a few minutes had all stabilized near their previous settings in response to me returning the mixture to a Rich-of-Peak (ROP) fuel flow. I began to relax and decided that I could tolerate the mask in favor of the extra altitude cushion, as I contemplated the fuel stop that running ROP would now require. Then, the gremlins awakened fully and the engine shook vigorously, like a dog getting rid of water. I scanned the engine monitor with darting eyes and saw the #6 CHT was rapidly rising through 370 degrees. I yanked the throttle back and requested an

immediate descent in what I hoped was a semi-calm voice. The #6 CHT's upward trend quickly reversed, but not before it peaked at something over 400 degrees [Figure 4].

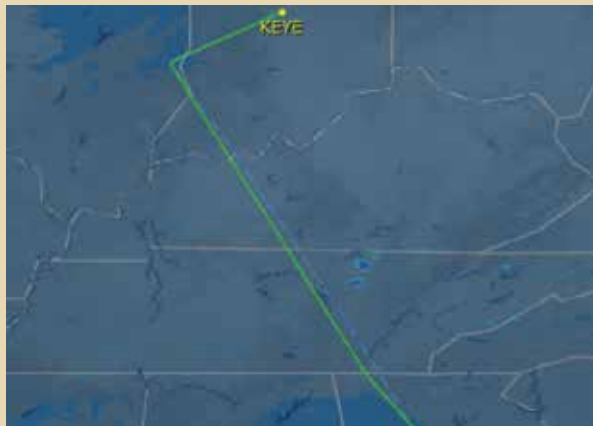
Figure 5: The flight's ground track from soon after reaching initial cruise altitude until landing. The diversion point is pretty obvious! The right turn put most of the 50-knot westerly wind on the tail, helping to expedite the arrival to the most suitable diversionary airport.

When I leveled at 12,000 feet and had the engine running smooth again, I transitioned from crisis mode to alternative mode. My primary goal is always to be safe. I felt like I had the situation under control and could continue safely to an airport within reasonable distance, rather than needing to declare an emergency and land immediately at an airport that might be less than ideal and only complicate my situation. To my left was St. Louis, straight ahead was Champagne, Ill., and to my right, Indianapolis. All were clear, but windy. Indy was closest, but more importantly, it was downwind. At my reduced power and speed, I'd rather have the 50-knot west wind pushing me. I was able to hold only about 120 KIAS, but with the tailwind component, my groundspeed should be above 150 KTS. The Indiana/Illinois border had just slipped beneath me before I made the hard right turn. I crossed it again, northeast-bound this time. I would not press on unless I could stay within gliding distances of suitable airports. Along my course were several airports, all of which I was familiar with. I'd never be more than eight miles or so from at least one of them (an easy glide distance from my altitude), so I shifted my attention to the airports between me and EYE, watching and waiting as one gave way to the next at the top of the Nearest Airports list. I acquired each visually along the way, setting its CTAF into the #2 COMM for good measure. Eighteen minutes to EYE [Figure 5].

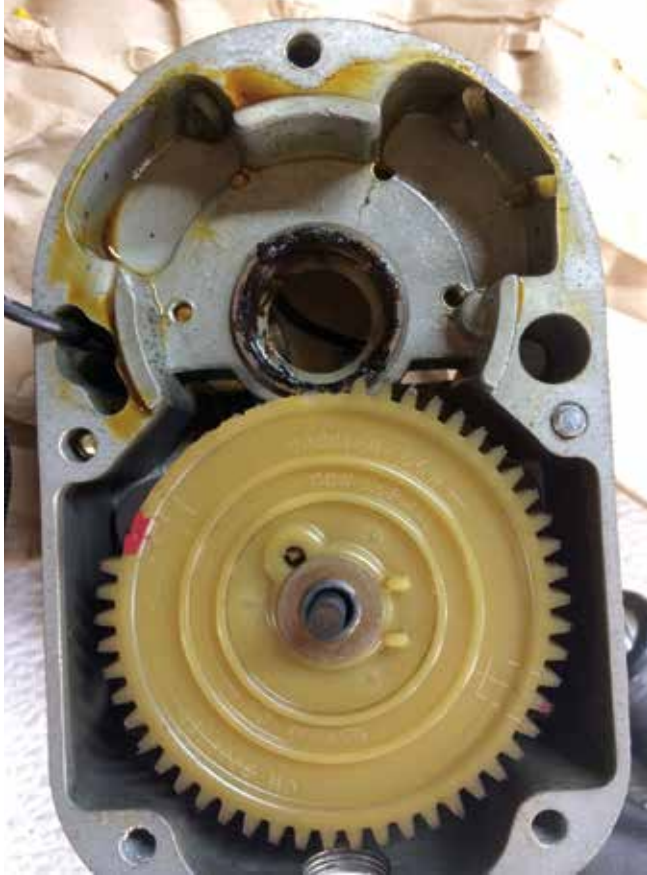
Photo 1: The failed magneto clearly missing about 25% of its drive-gear teeth. Yet, enough teeth remained to allow it to function in a reduced and intermittent capacity (which was probably worse than if it had just totally failed).

[Postscript: Hindsight may be 20/20, but hindsight aided by digital engine data is more like 20/10! It was satisfying to have answers. Three separate engine issues were noted in post-flight maintenance; a stripped magneto drive gear (see Photo 1), a malfunctioning (#6) sparkplug whose porcelain insulator had separated from the resistor, and three cylinders with improper valve guide tensions. Although it was impossible to say precisely which issues caused which reactions, as all three likely had at least some role in the ignition and temperature issues. What one can say is that any one of them would have been less problematic by itself (and maybe none of them would have manifested at all below the flight level altitudes). In combination, one problem likely helped to cause or exasperate the others, combining them into a bit of a "perfect storm." If I had it to do over, would I do it differently? Probably. While I stand by my judgment calls made in the heat of the moment (resulting in a safe and successful completion of the mission a couple days later), I would be foolish to ignore the lessons learned and not add them into my future crisis-decision-making.]
